# Knee Prosthesis

## Postoperative Imaging

Anna Hirschmann, MD

Clinic of Radiology and Nuclear Medicine

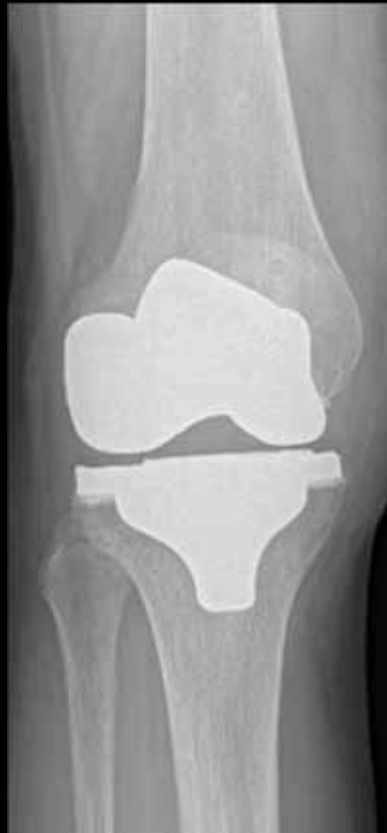
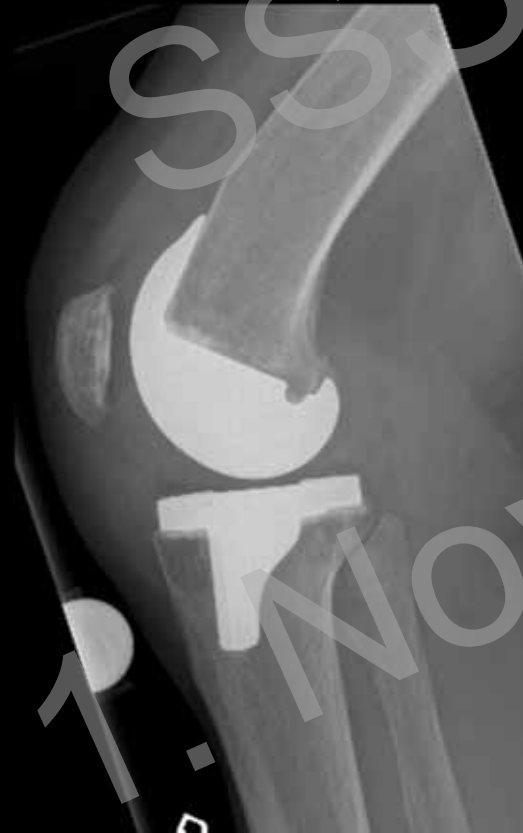
Radiographs: → size, position, osteolysis, fracture

- ap/lat WB and patella ax:

Detection of osteolysis:  
Sensitivity 17-56% X-ray  
>70% CT / MR

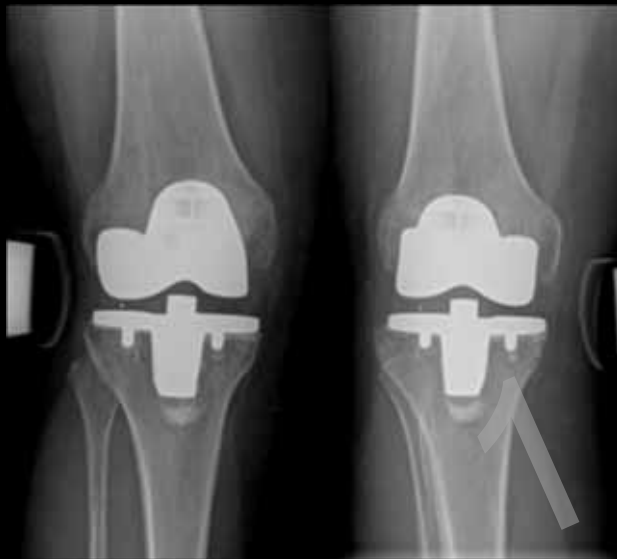
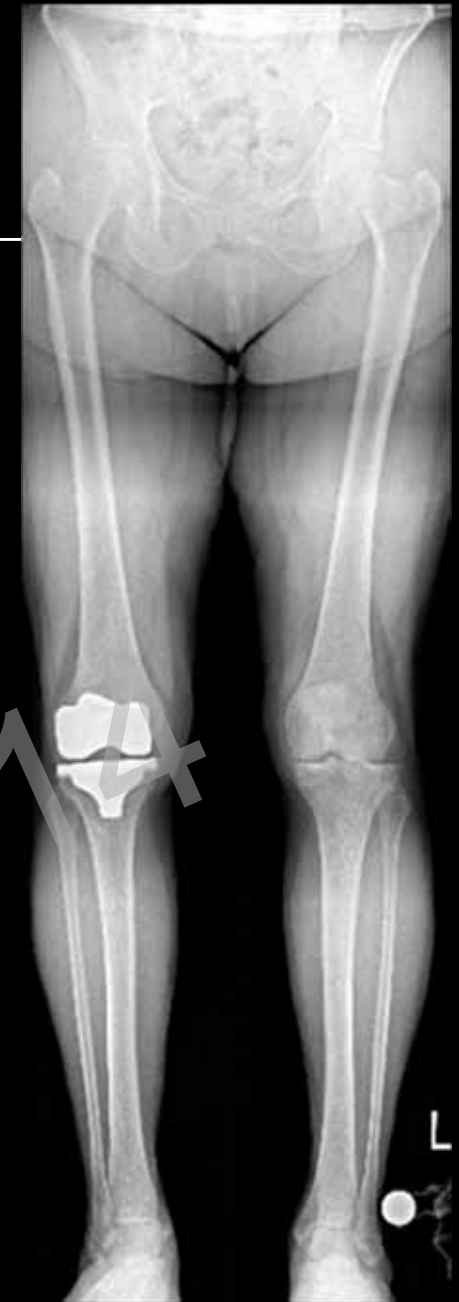
- Full-leg ap WB:
  - ➔ mechanical alignment
- Varus/valgus  $\pm$  ap stress views:
  - ➔ flexion/extension gap/ ap translation

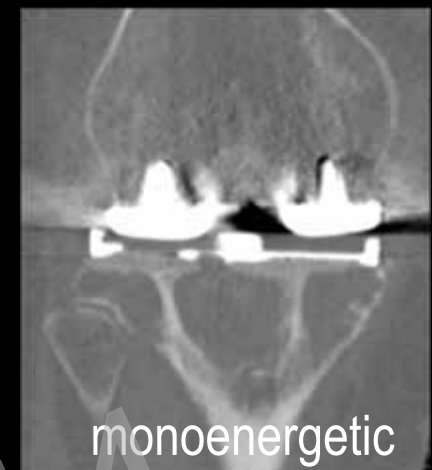
- Metal artifact reduced algorithm (DECT)
- Extended scale (max WL/WW)

regular

monoenergetic

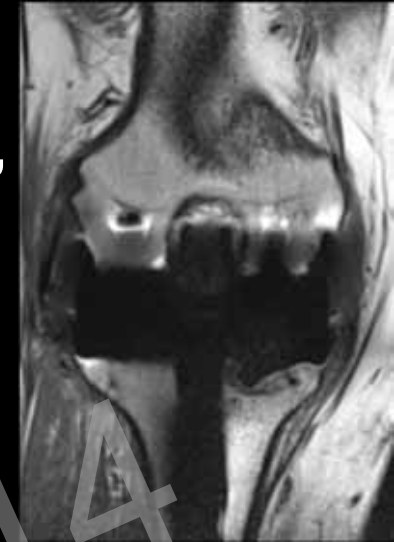
osteolysis, edema, soft tissue

- Metal artifact reduced sequences (VAT, HBW, SEMAC)

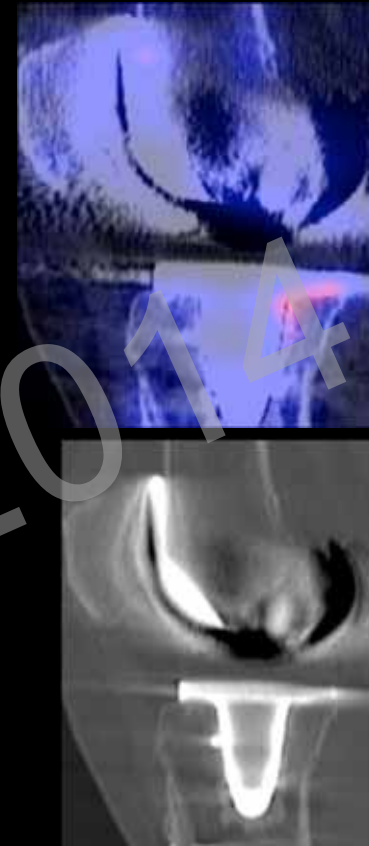
Higher tibial slope =

BTU

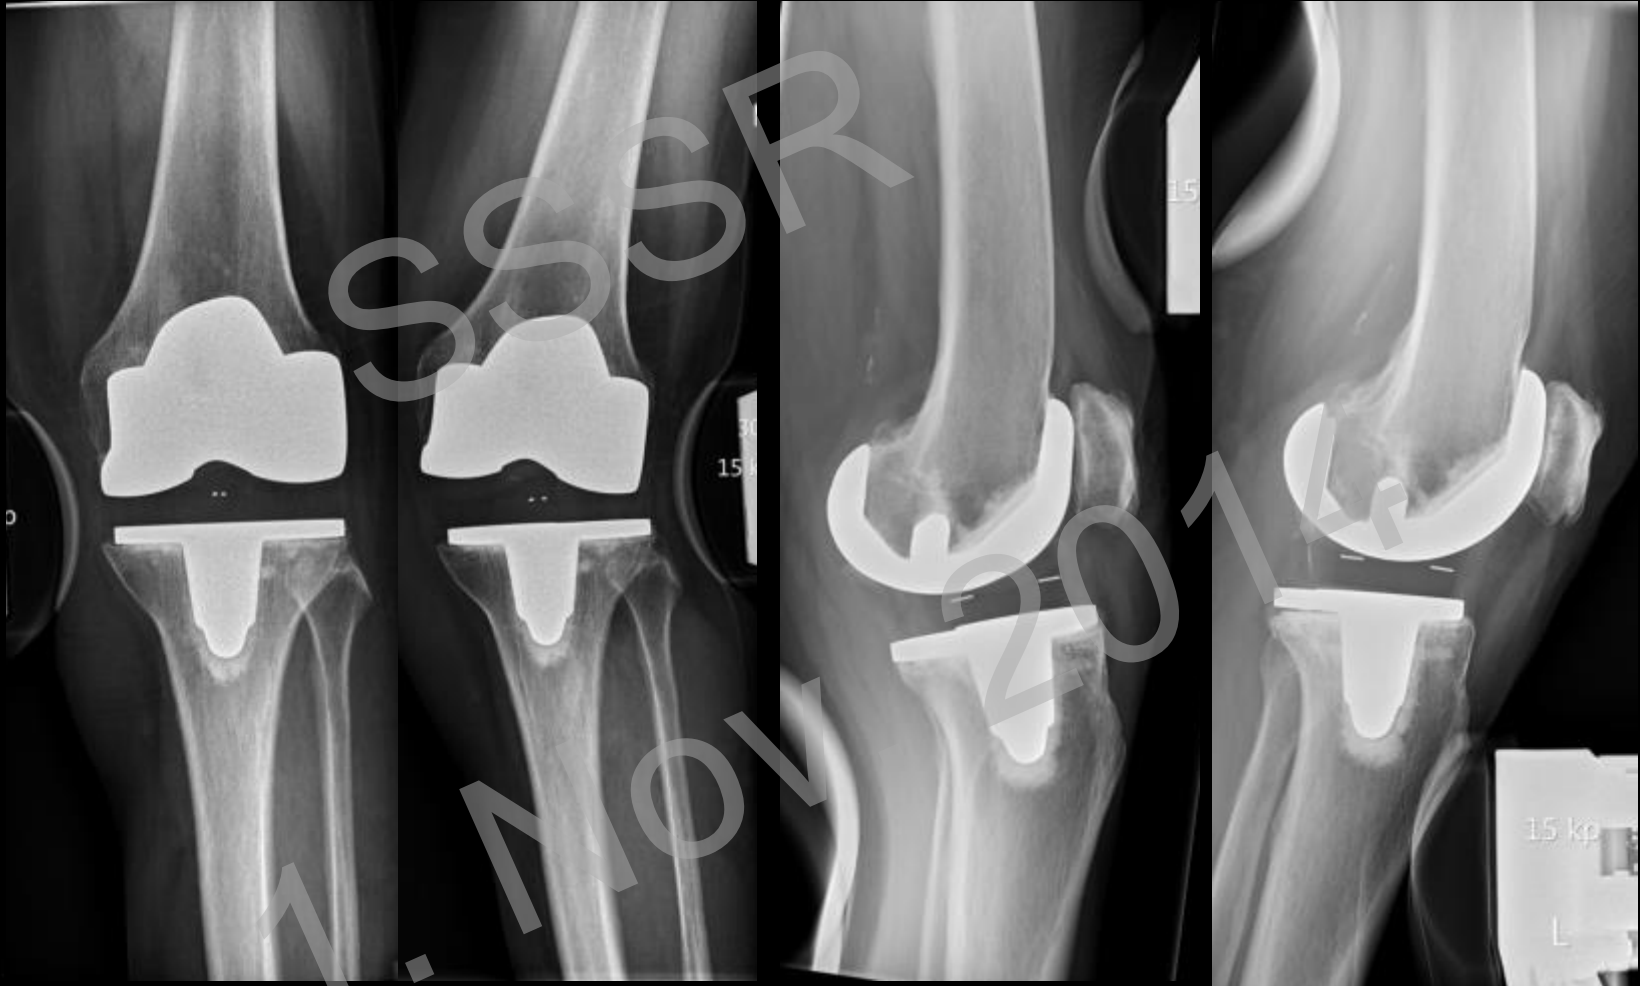
Increased medial JS = Valgus laxity

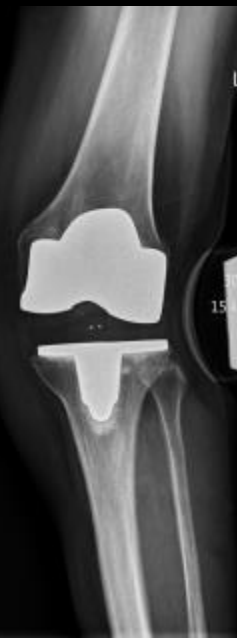
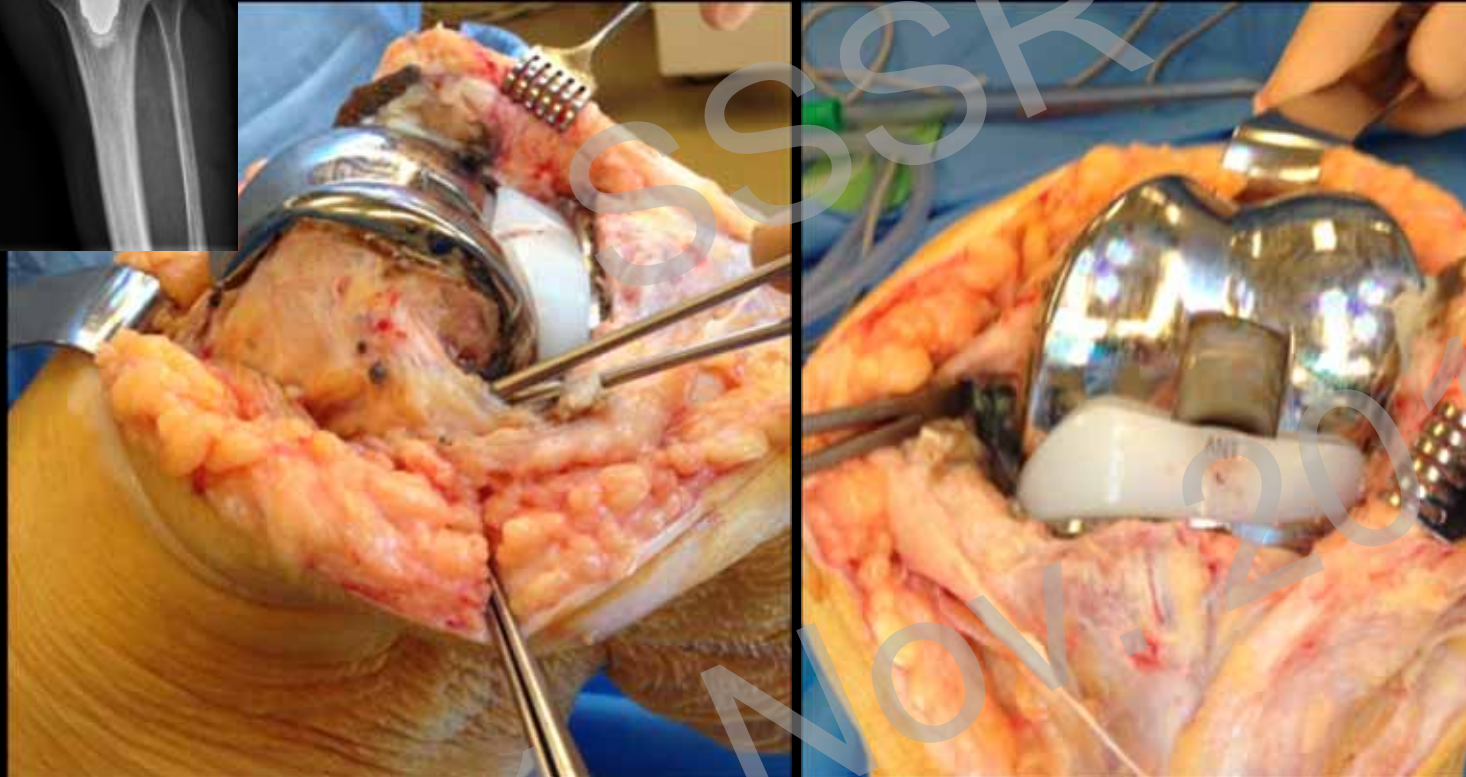
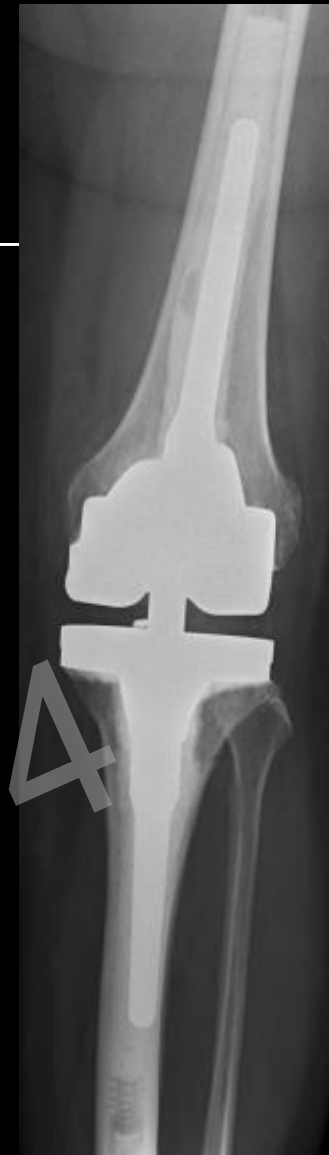
Medial ligament insufficiency after previous intraoperative repair

Rotating Hinge TKA

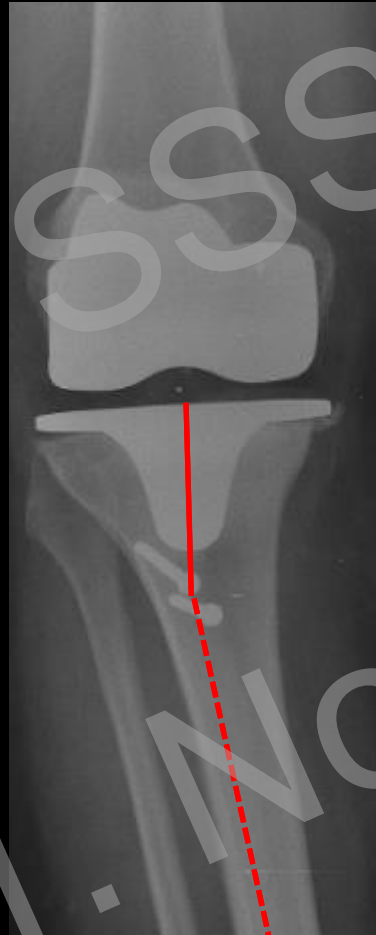
Tibial varus

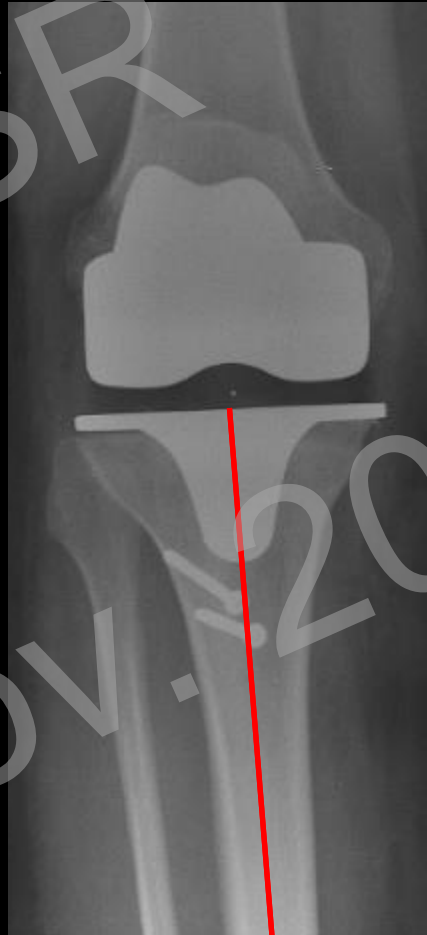
Normal tibial component alignment

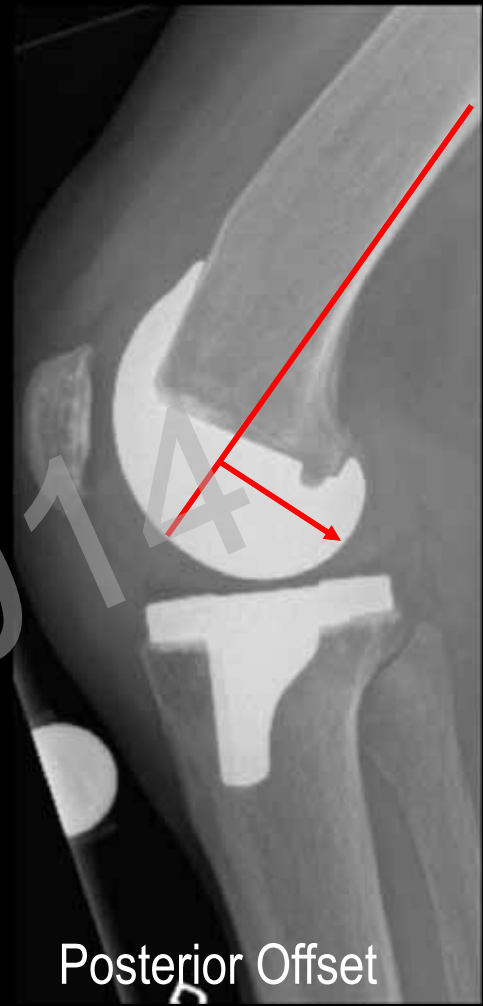
Posterior Offset

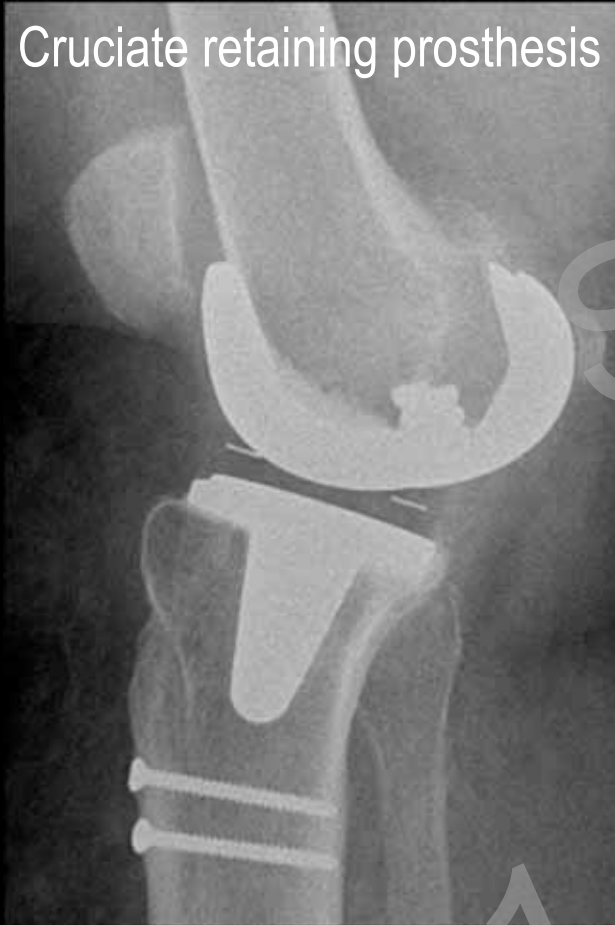
Cruciate retaining prosthesis

High posterior tibial slope

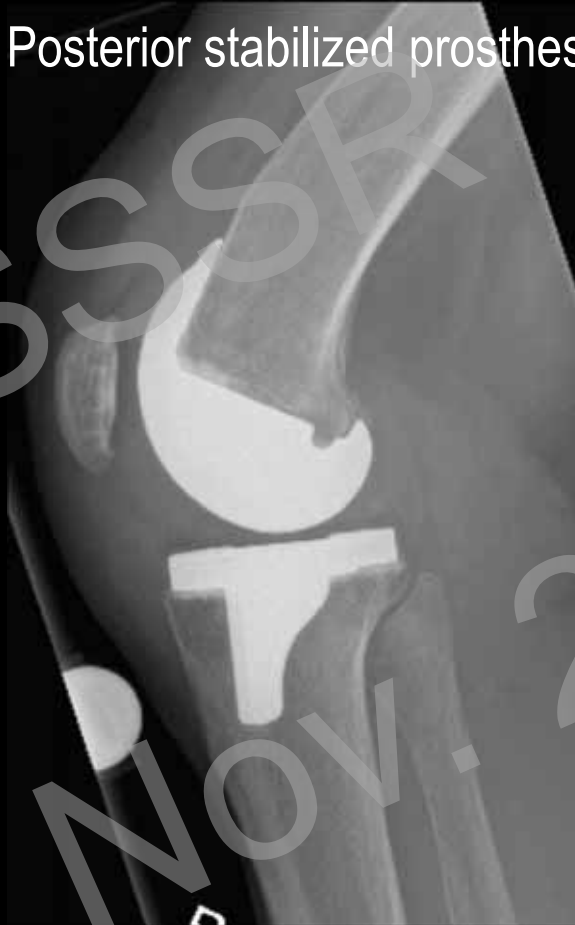
Posterior stabilized prosthesis

Normal:  
0-3° posterior tibial slope (PS)/as  
preoperative (CR)

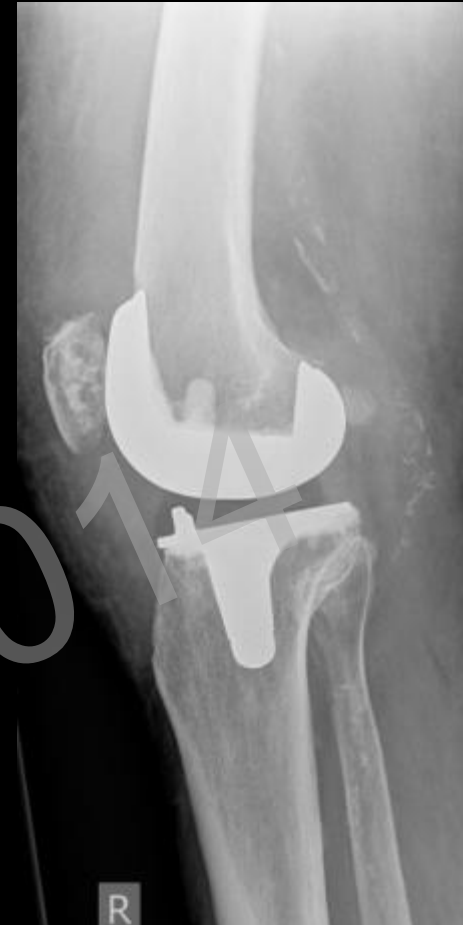
Anterior tibial slope

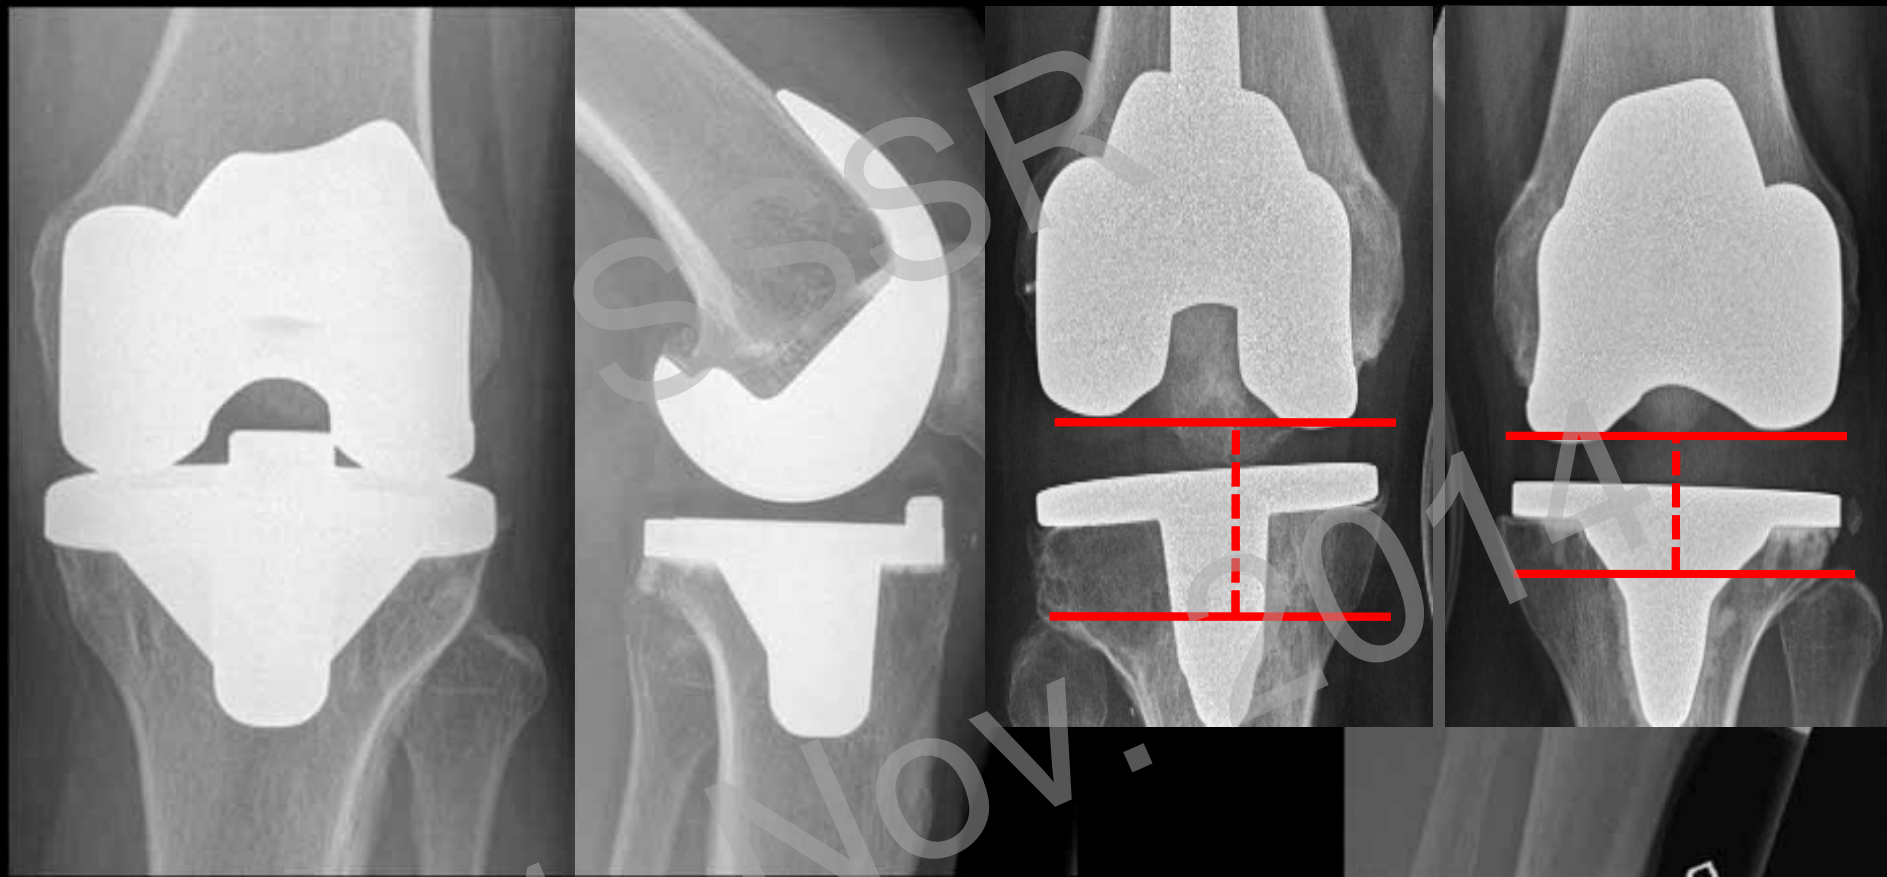
- Elevated joint line
- Pseudopatella baja

Normal joint line

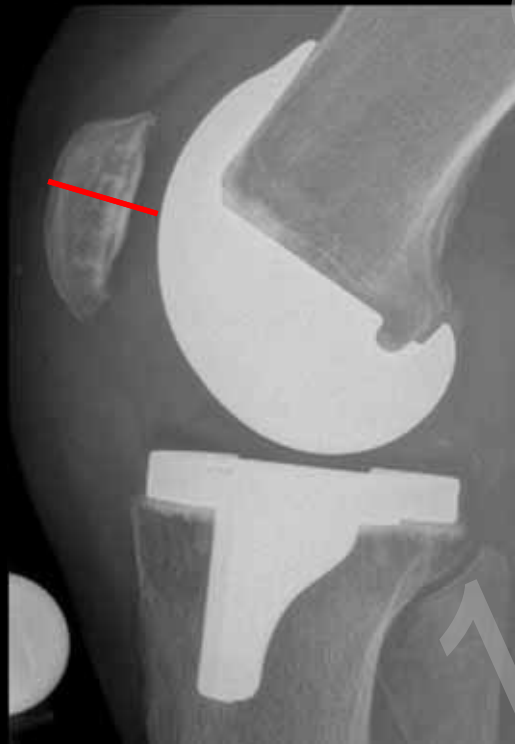
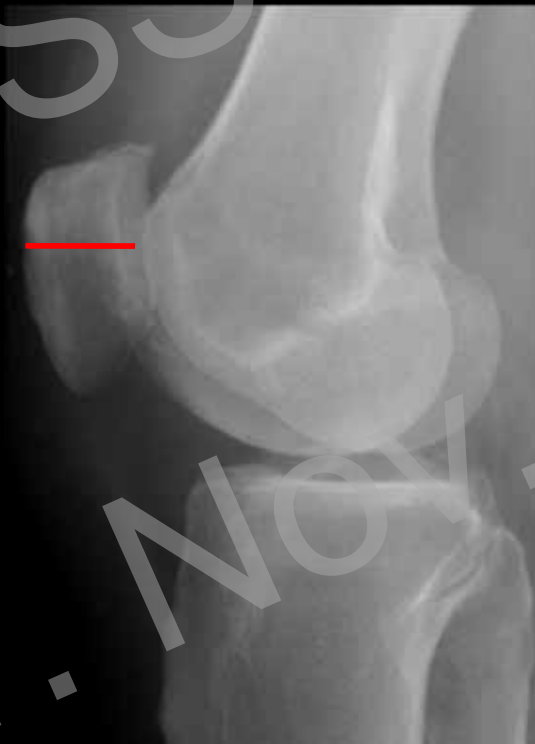
- Position of patella (thumb-rule patella height same way as to the tibia plateau)
- Ap thickness patella+PE = native patella  $\geq$  PF Overstuffing

Normal: no tilting

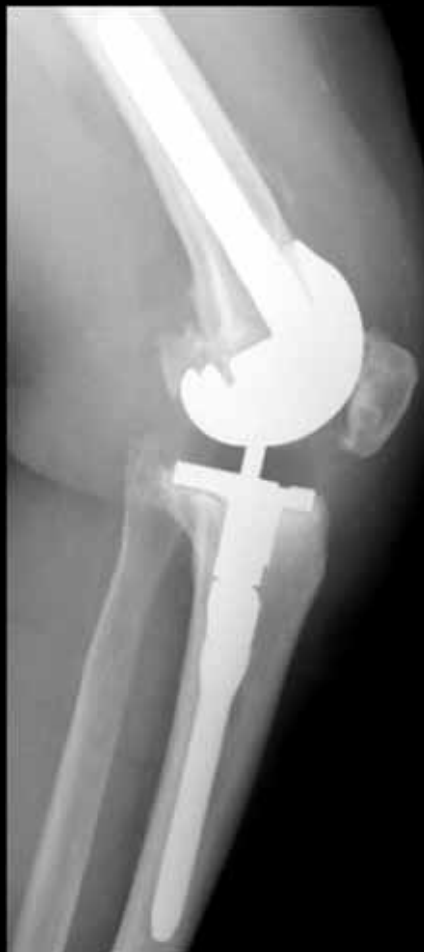
Patella baja

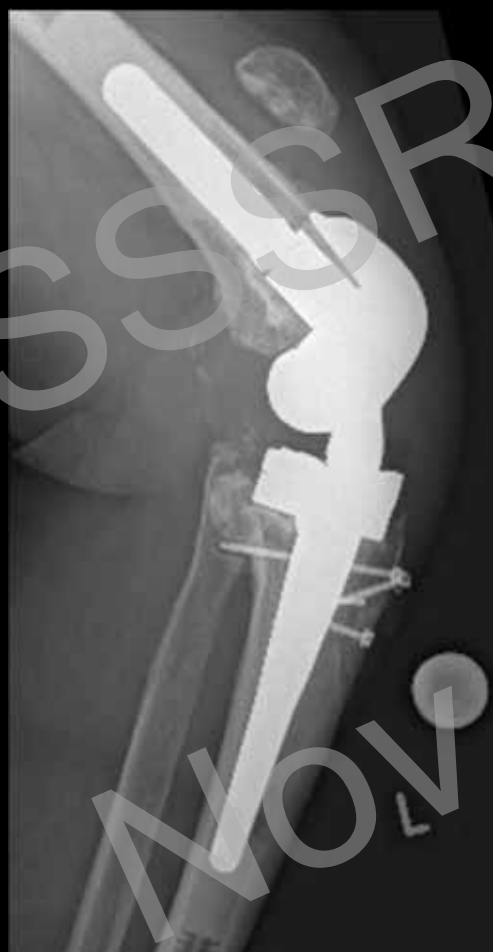
Patella alta after revision

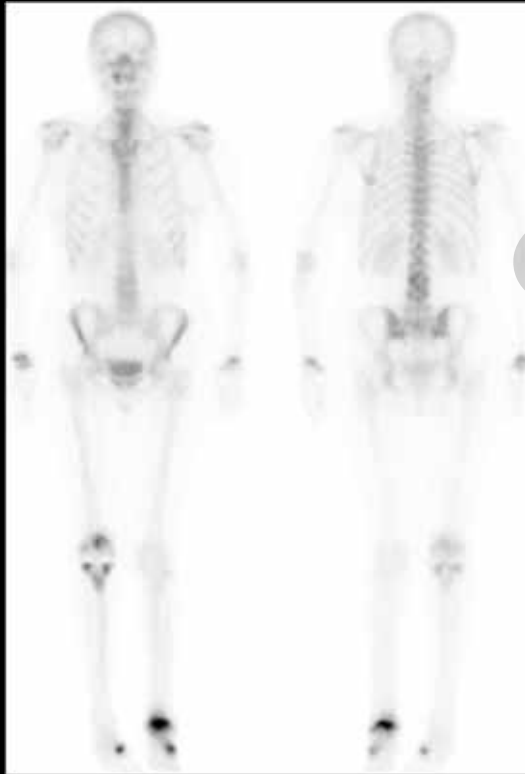
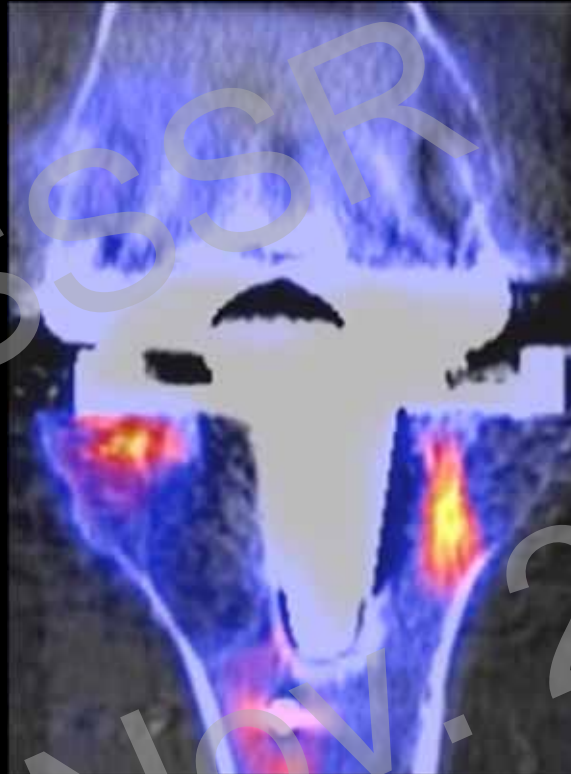
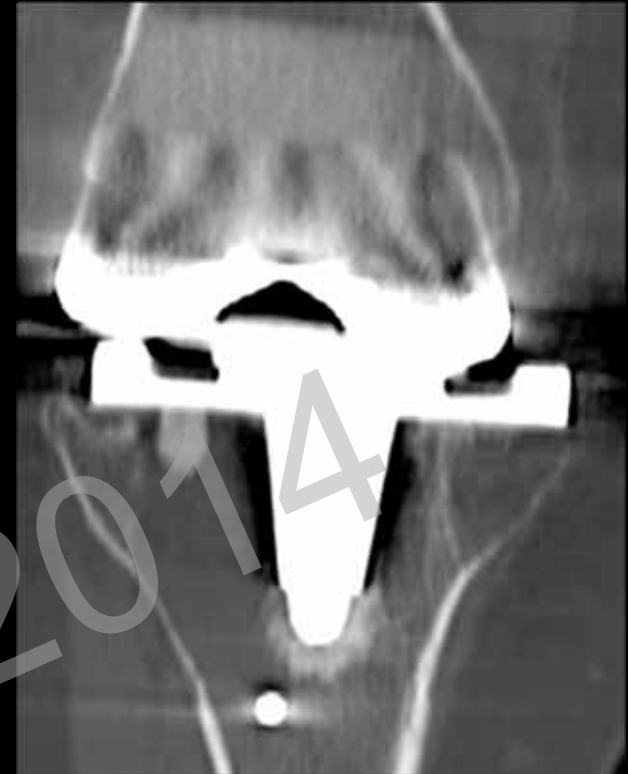
Mechanical stress, particle debris with osteolysis  
Fx of Inlay and subsidence of tibial component

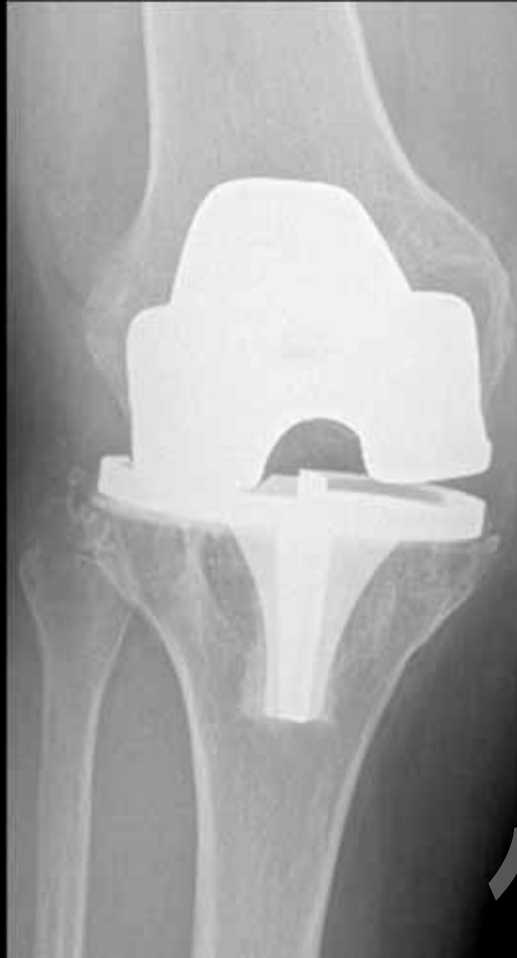
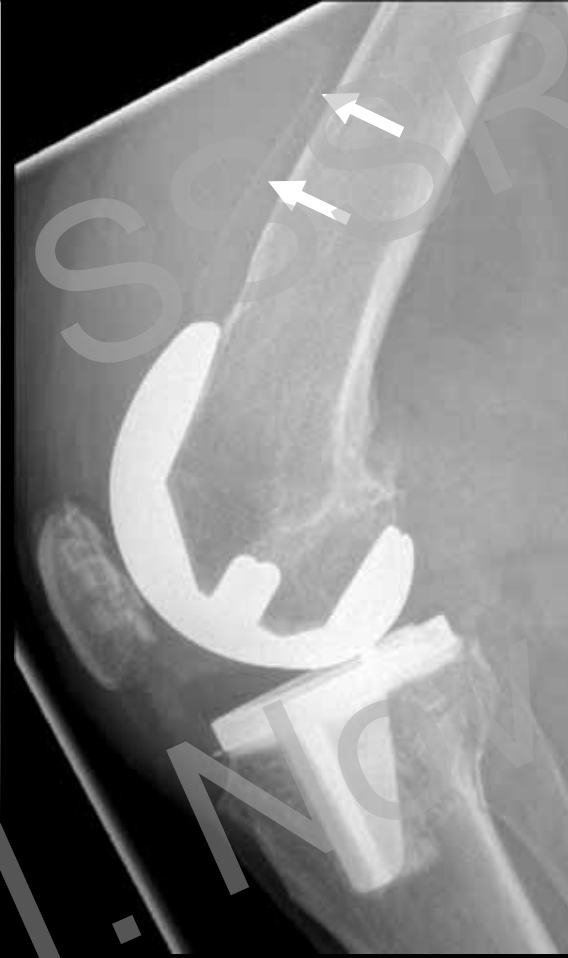
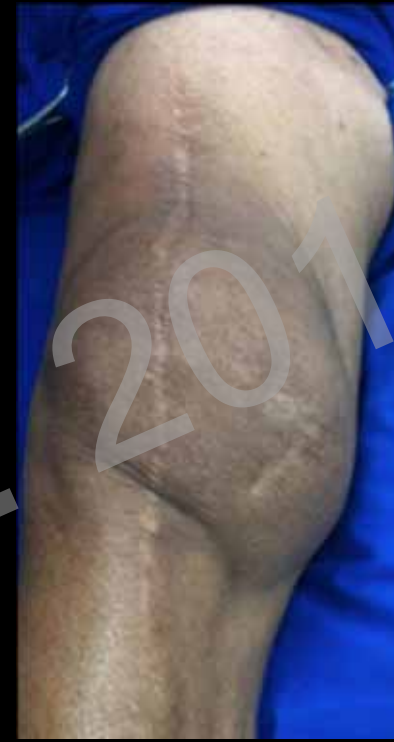
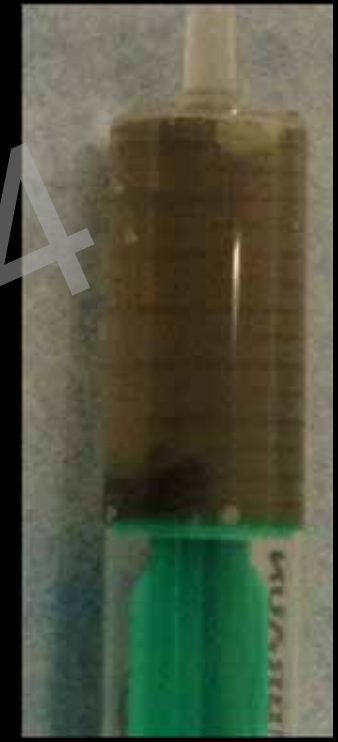
Metal line sign

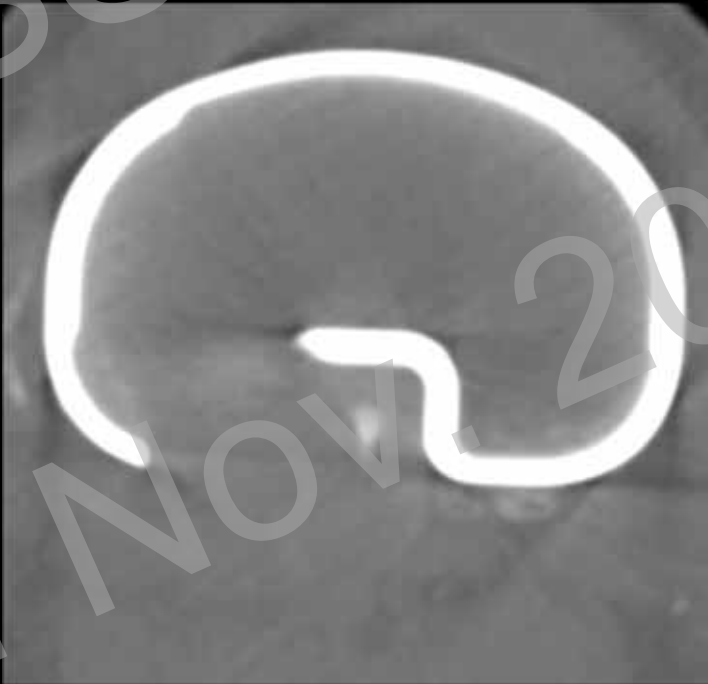
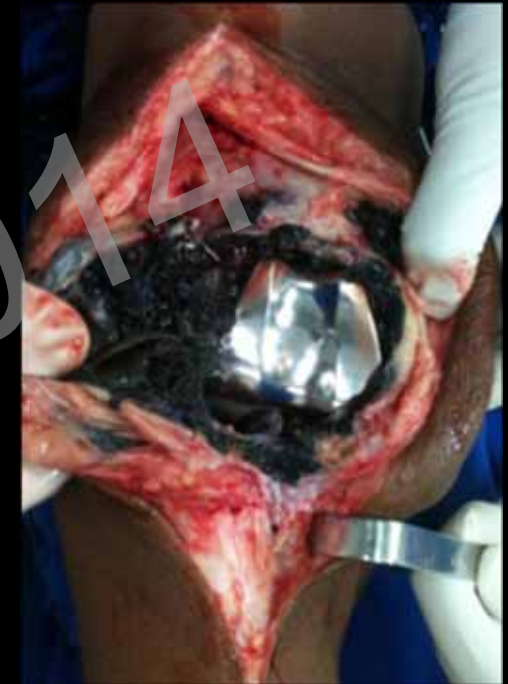
- Prosthetic fracture
- PE Wear
- Metallosis

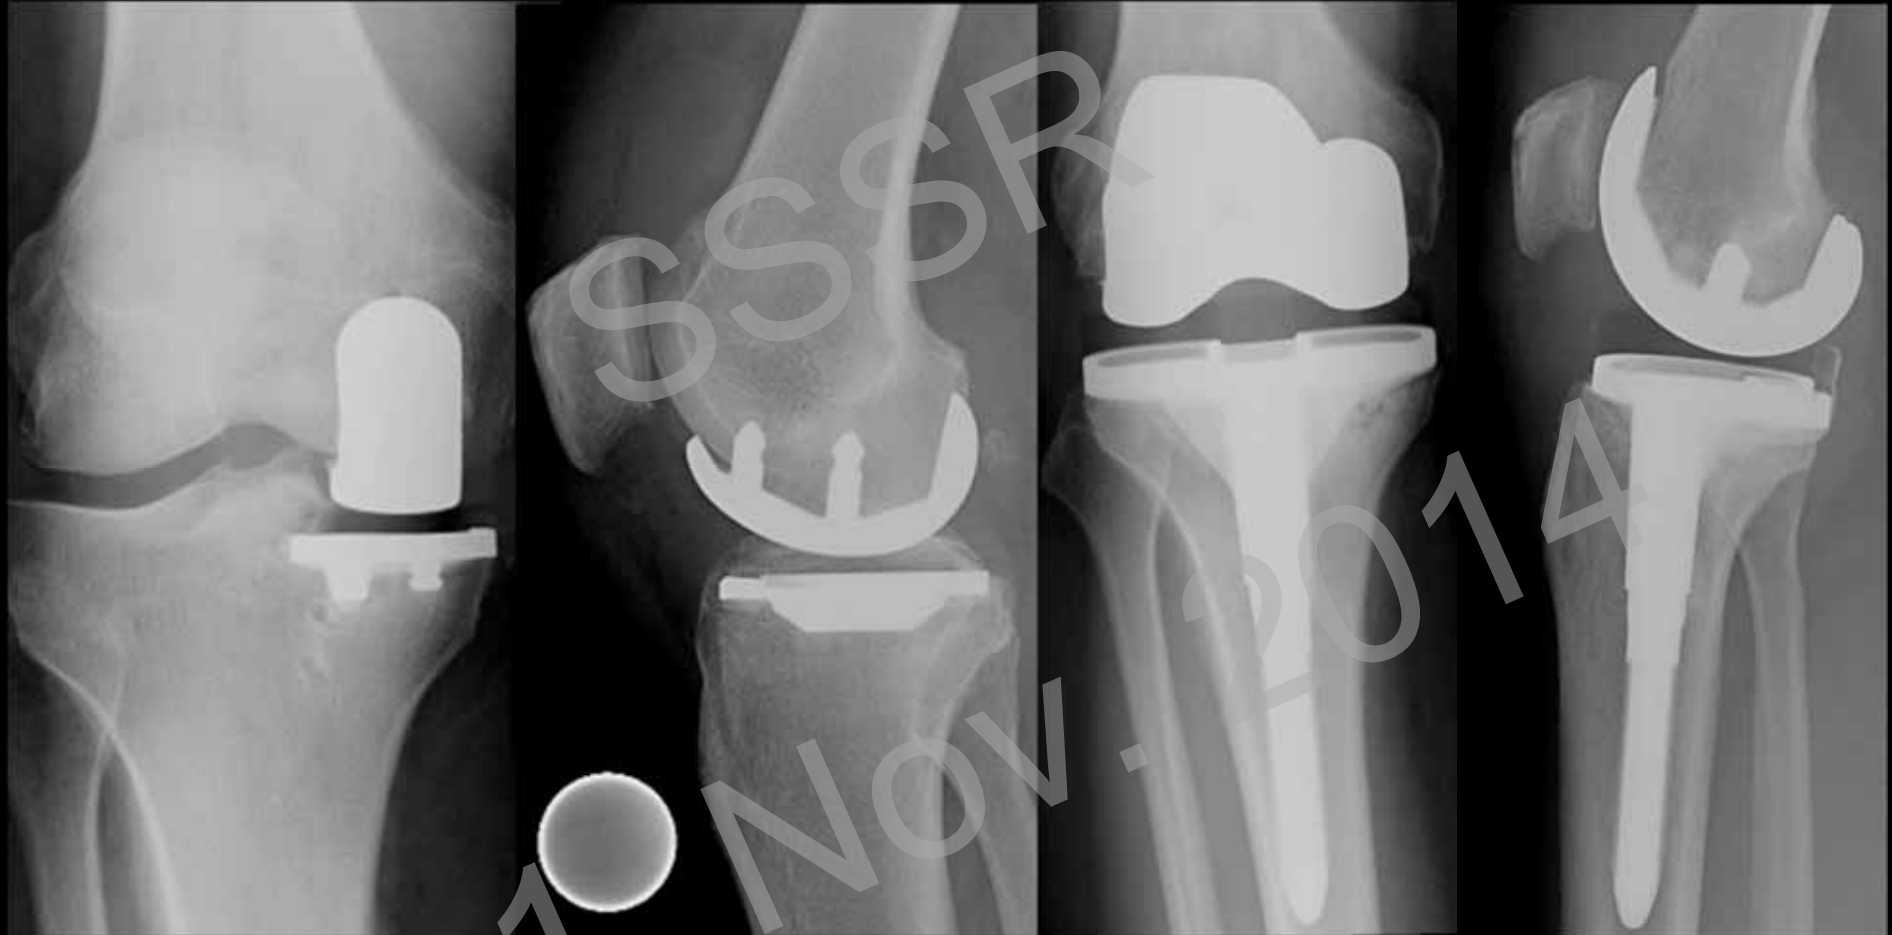
Tibial loosening and subsidence  
Eminentia impingement

Revision, still pain / restricted motion

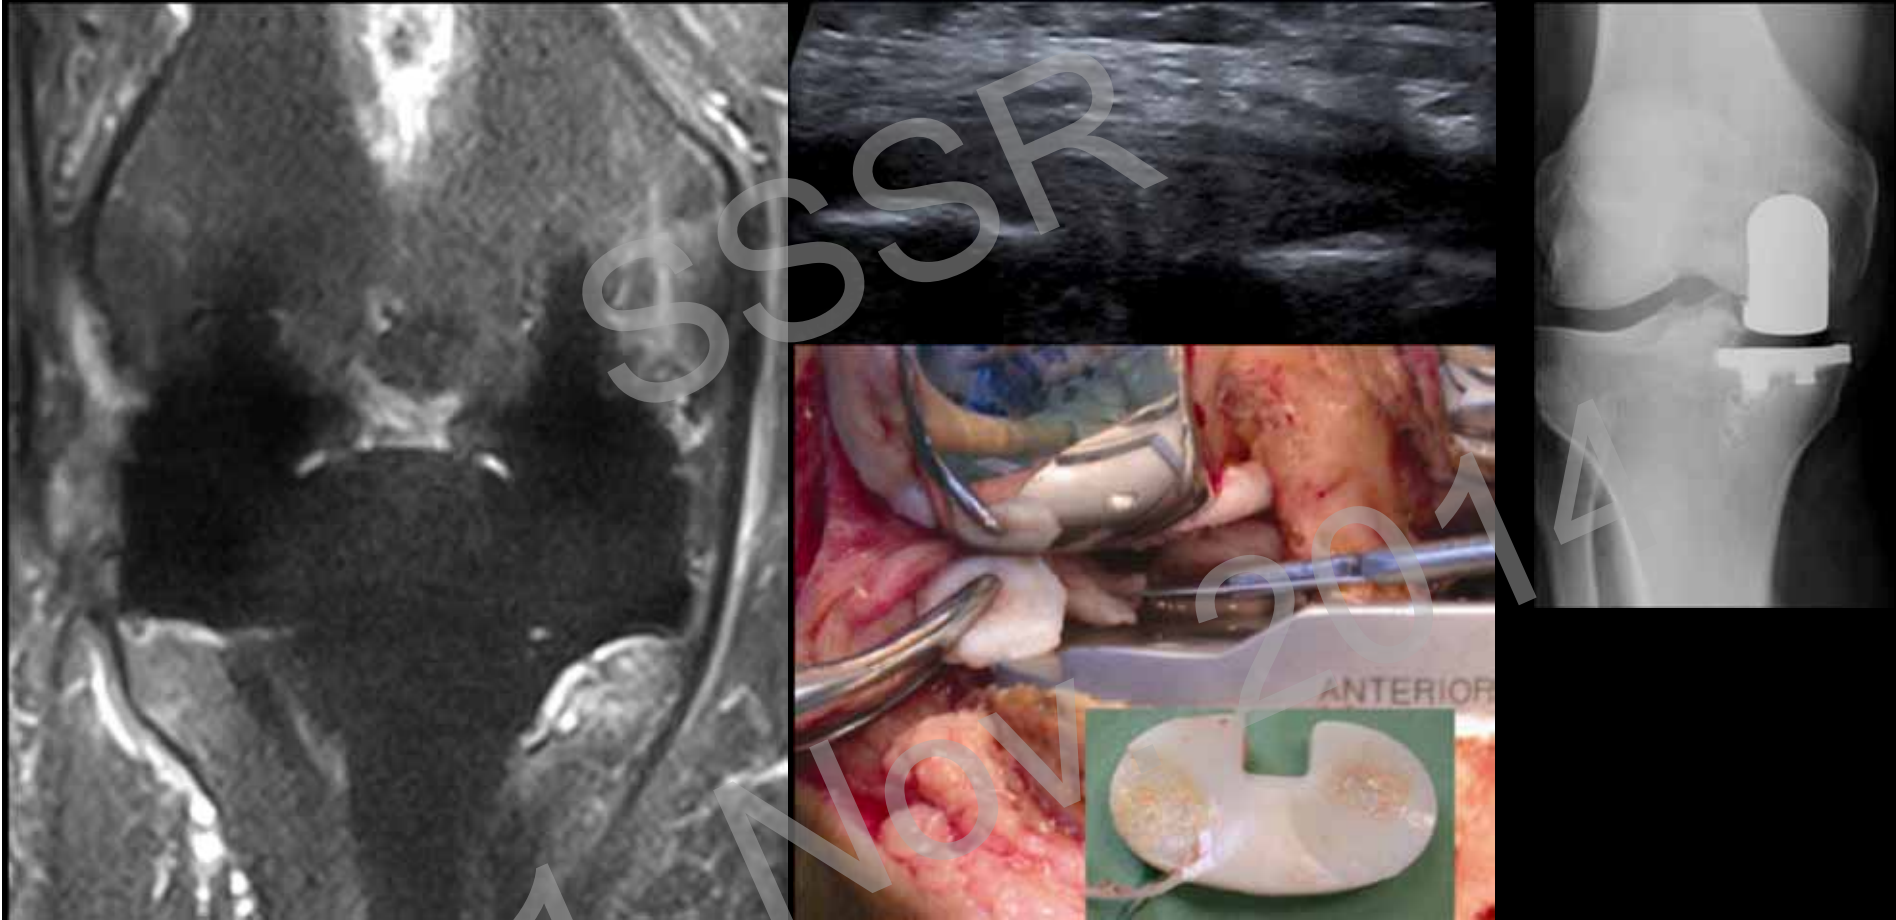
Remnant meniscus/Pseudomeniscus

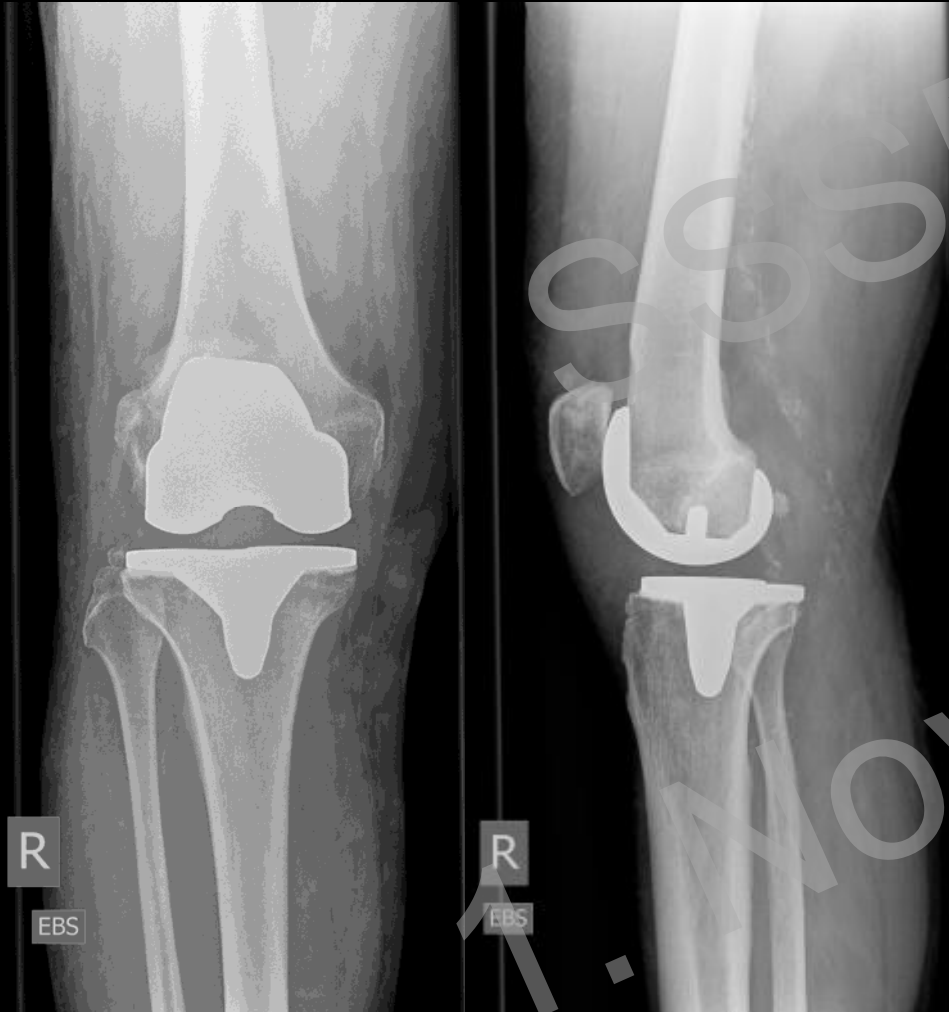
- TKA 1 year ago
- arthroscopic arthrolysis
- persistent pain
- restricted flexion 90°

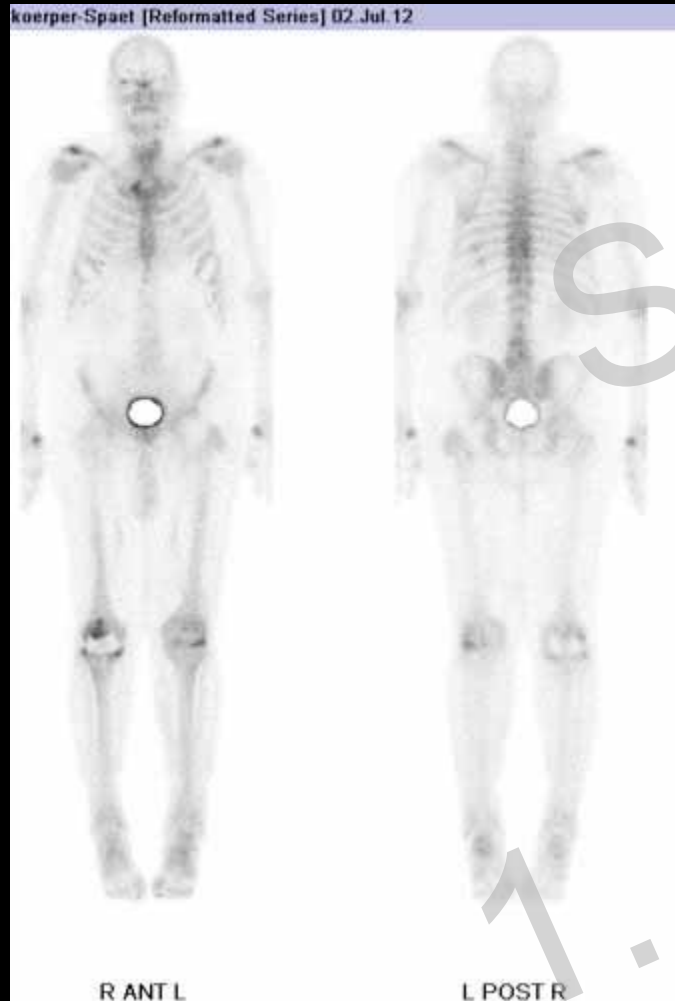
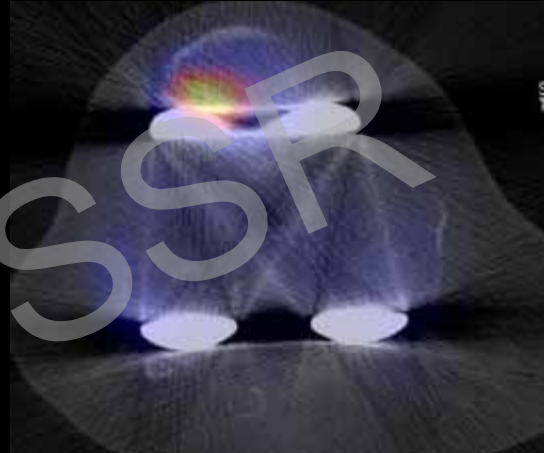
Patella hyperpression  
Anything else?

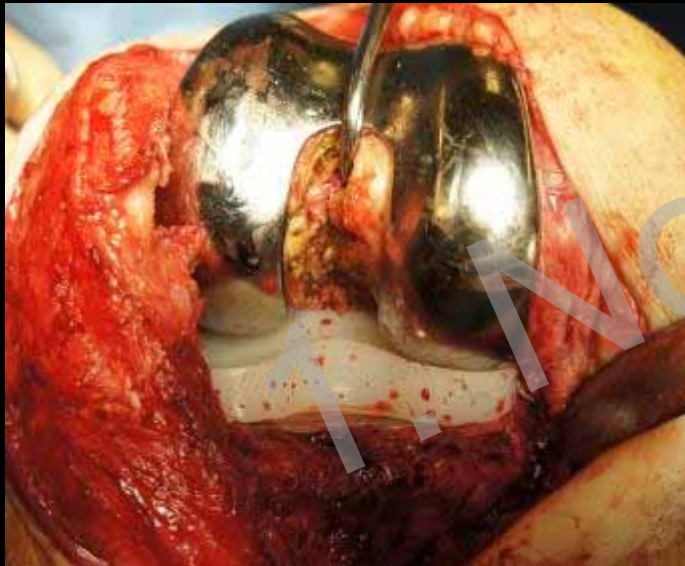
normal  
Secondary patellar  
resurfacing

180° spin out of inlay
